NASA/TP-97-206257

The Characteristics of Fatigue Damage in the Fuselage Riveted Lap Splice Joint

Robert S. Piascik
Langley Research Center, Hampton, Virginia

November 1997

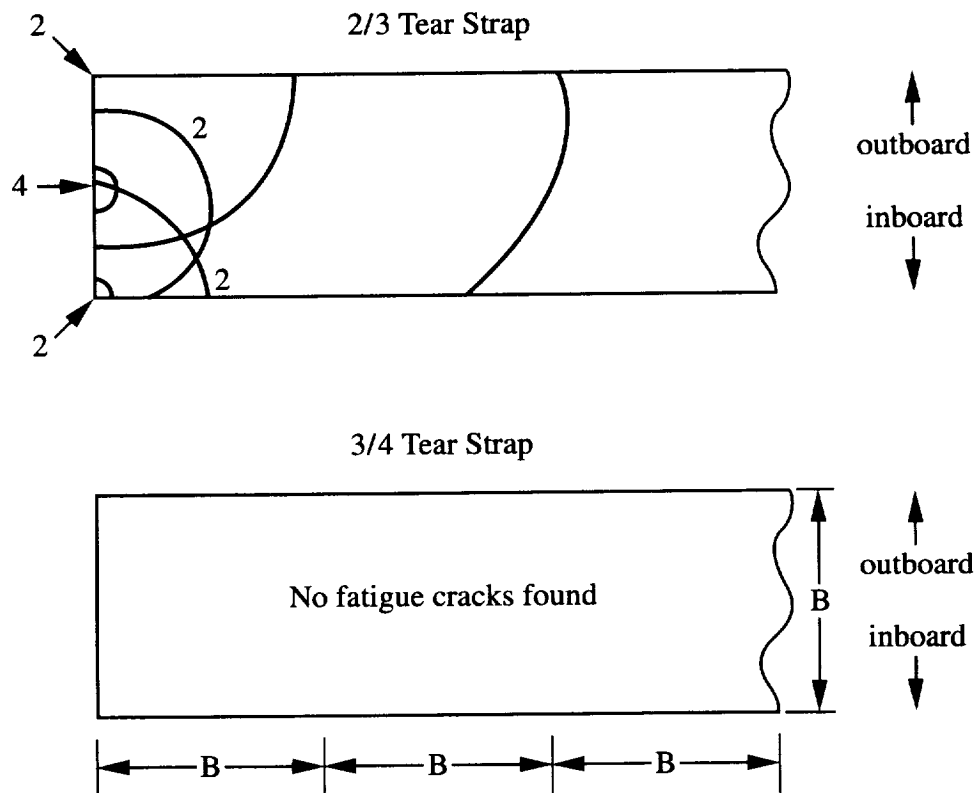
Figure 12.4 A schematic of a) bay 2/3 tear strap and b) bay 3/4 tear strap inner skin rivet hole region and the location of fatigue crack initiation (arrows) and the final fatigue crack front configuration (curved lines). The numbers denote the quantity of fatigue cracks or initiation sites found in the given crack front and initiation regions.

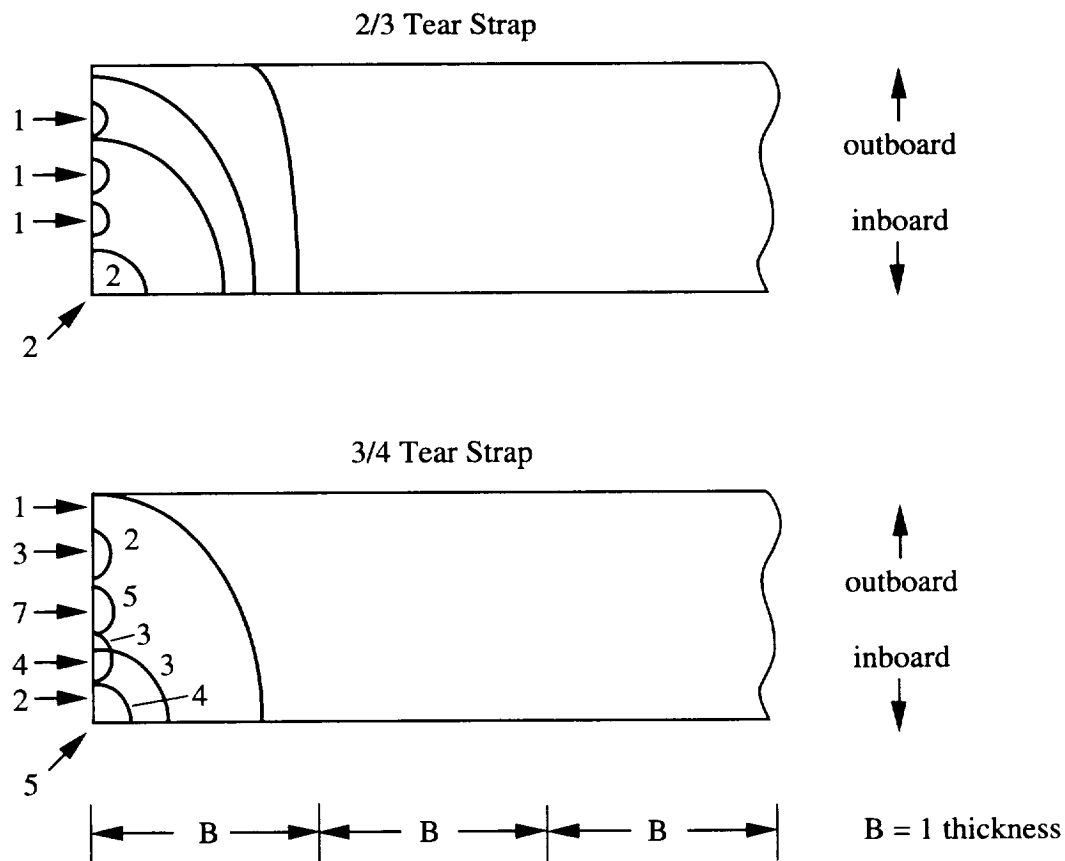
Figure 12.5 A schematic of a) bay 2/3 tear strap and b) bay 3/4 tear strap upper tear strap rivet hole region and the location of fatigue crack initiation (arrows) and the final fatigue crack front configuration (curved lines). The numbers denote the quantity of fatigue cracks or initiation sites found in the given crack front and initiation regions.

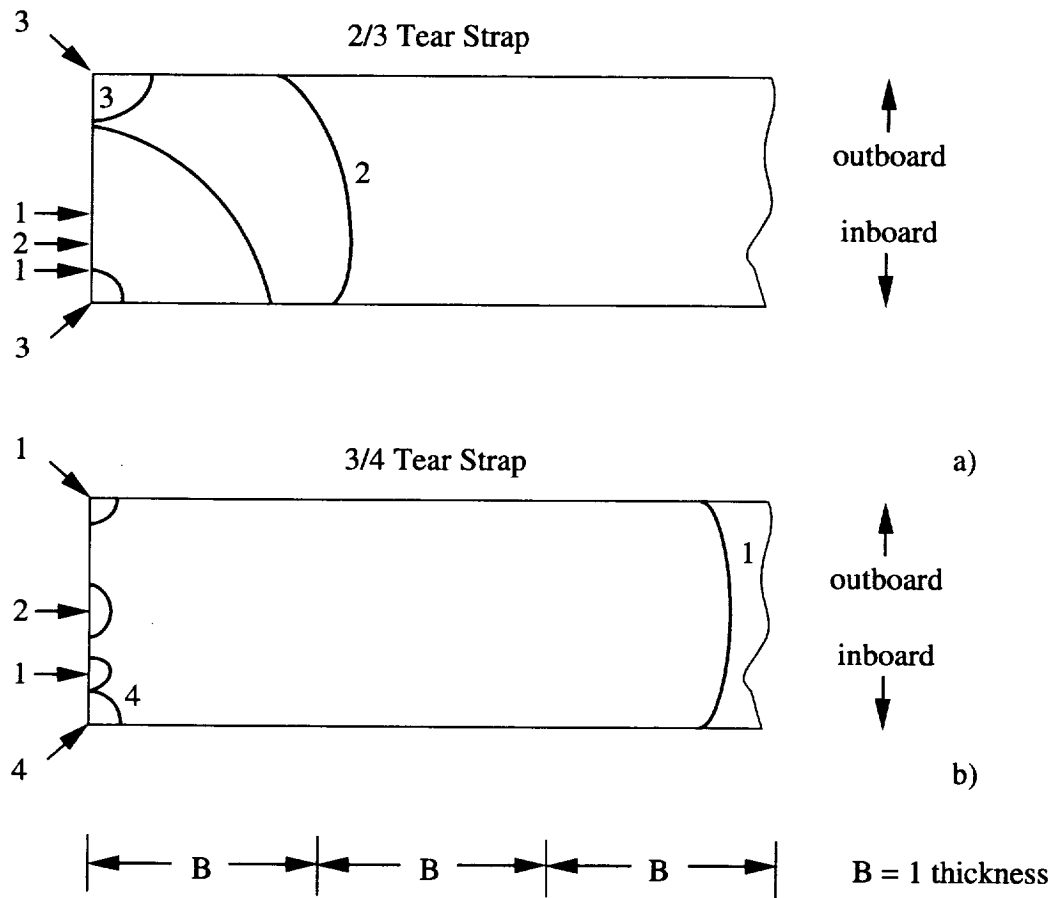
Figure 12.6 A schematic of a) bay 2/3 tear strap and b) bay 3/4 tear strap lower tear strap rivet hole region and the location of fatigue crack initiation (arrows) and the final fatigue crack front configuration (curved lines). The numbers denote the quantity of fatigue cracks or initiation sites found in the given crack front and initiation regions.

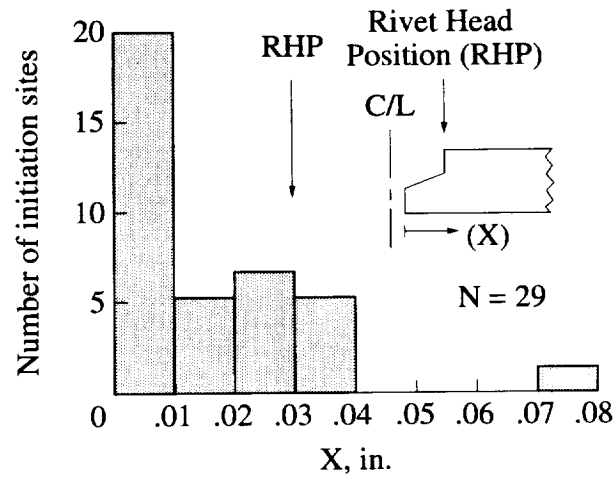
The majority of fatigue cracks found in the outer skin of the lap splice joint initiated along the faying surface under the rivet head. A summary of crack initiation location data for bays 2, 3, and 4 are shown in Figures 12.7, 12.8, and 12.9, respectively. These plots show the frequency of occurrence of outer skin fatigue crack initiation sites as a function of the distance (X) from the rivet hole along the faying surface. The data in Figure 12.7 shows the faying surface crack initiation site distribution for a total twenty-nine fatigue cracks observed in bay 2. Here, the location of 38 crack initiation sites are plotted; the number of initiation sites is larger than the total number of fatigue cracks because many fatigue cracks exhibited multiple initiation sites. It is important to note that a considerable number of cracks initiated a significant distance, ranging from 0.25 mm (0.01 inch) to 2.0 mm (0.08 inch), from the rivet hole. Crack initiation along the faying surface suggest that fretting damage between the inner and outer skin surfaces promote fatigue cracking in the lap splice joint rivet holes. Similar faying surface crack initiation distributions were observed for bays 3 and 4.

Figure. 12.7 The graph shows the distribution of bay 2 fatigue crack initiation sites located along the X-direction (faying surface) defined in the schematic. For orientation purposes the edge of the rivet hole (RHP) is shown at $X=0.03$ " from the edge of the rivet shank.

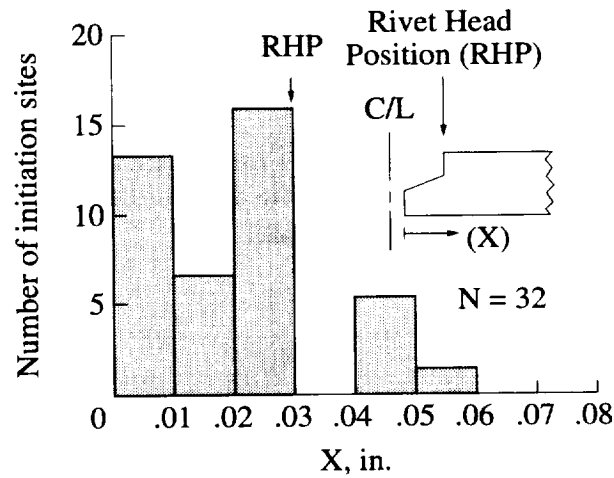
Figure 12.8 The graph shows the distribution of bay 3 fatigue crack initiation sites located along the X-direction (faying surface) defined in the schematic. For orientation purposes the edge of the rivet hole (RHP) is shown at $X=0.03$ " from the edge of the rivet shank.

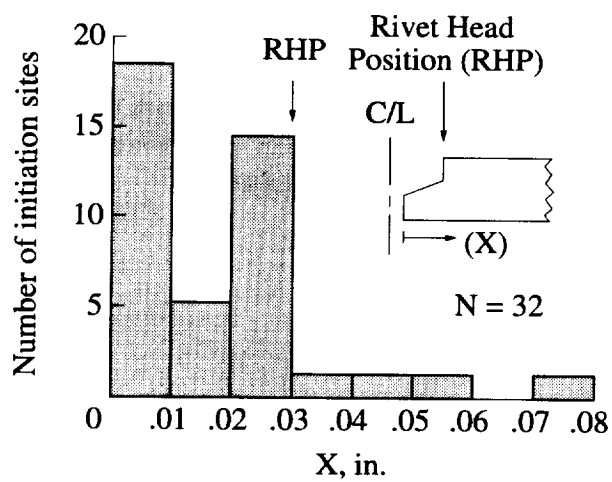
Figure 12.9 The graph shows the distribution of bay 4 fatigue crack initiation sites located along the X-direction (faying surface) defined in the schematic. For orientation purposes the edge of the rivet hole (RHP) is marked at 0.03" from the edge of the rivet shank.

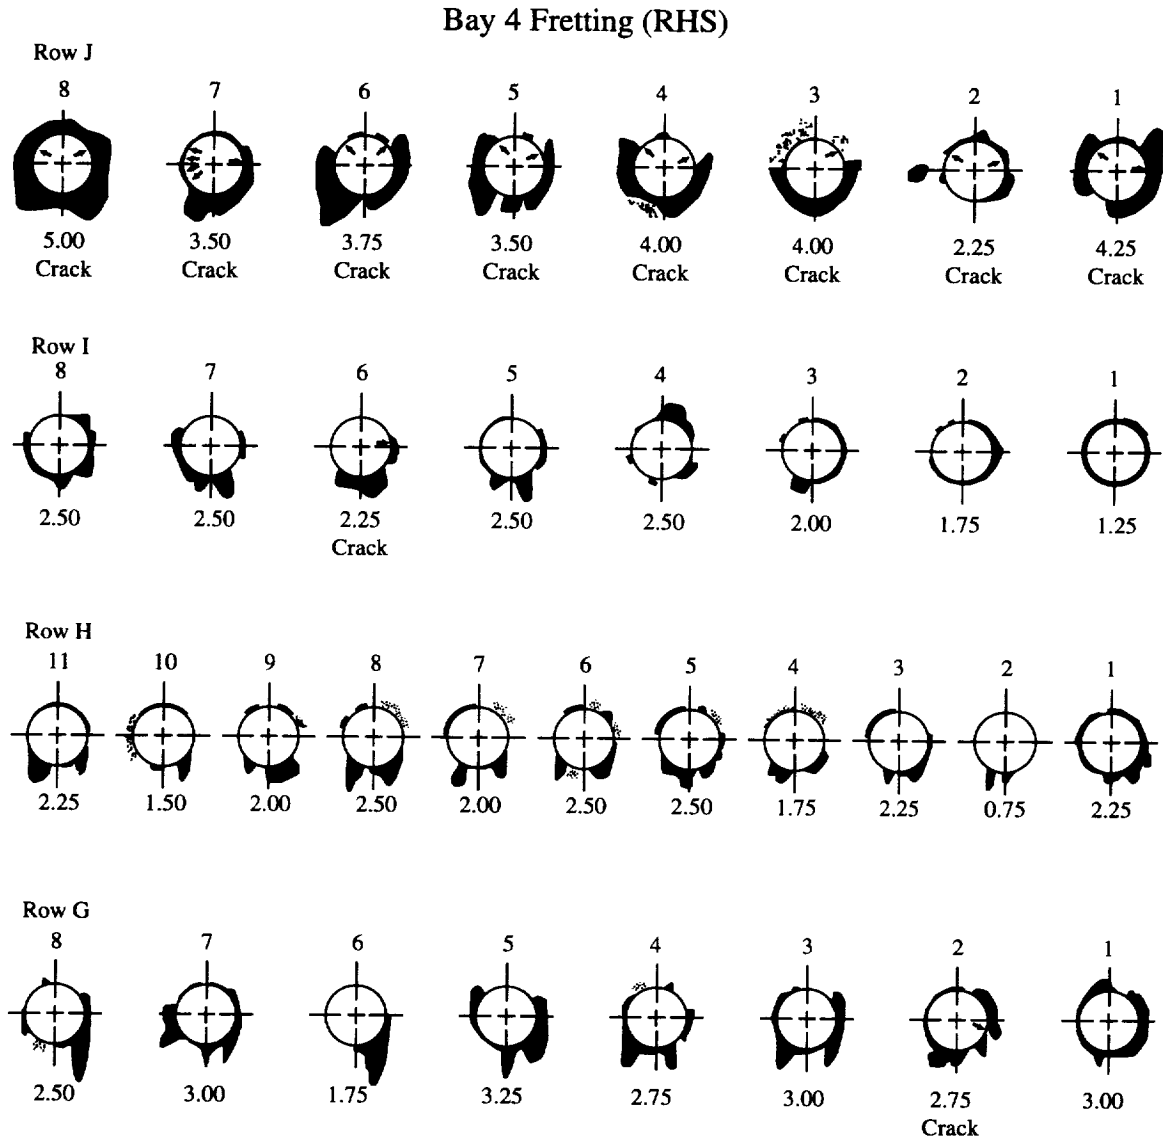
Figure 13.3a A schematic showing a portion of the inboard surface of the bay 4 lap splice outer skin. Illustrated is the location of black oxide fretting debris, the location of fretting initiated fatigue cracks (arrows), and the fretting average (FA) value defined in Figure 13.4.

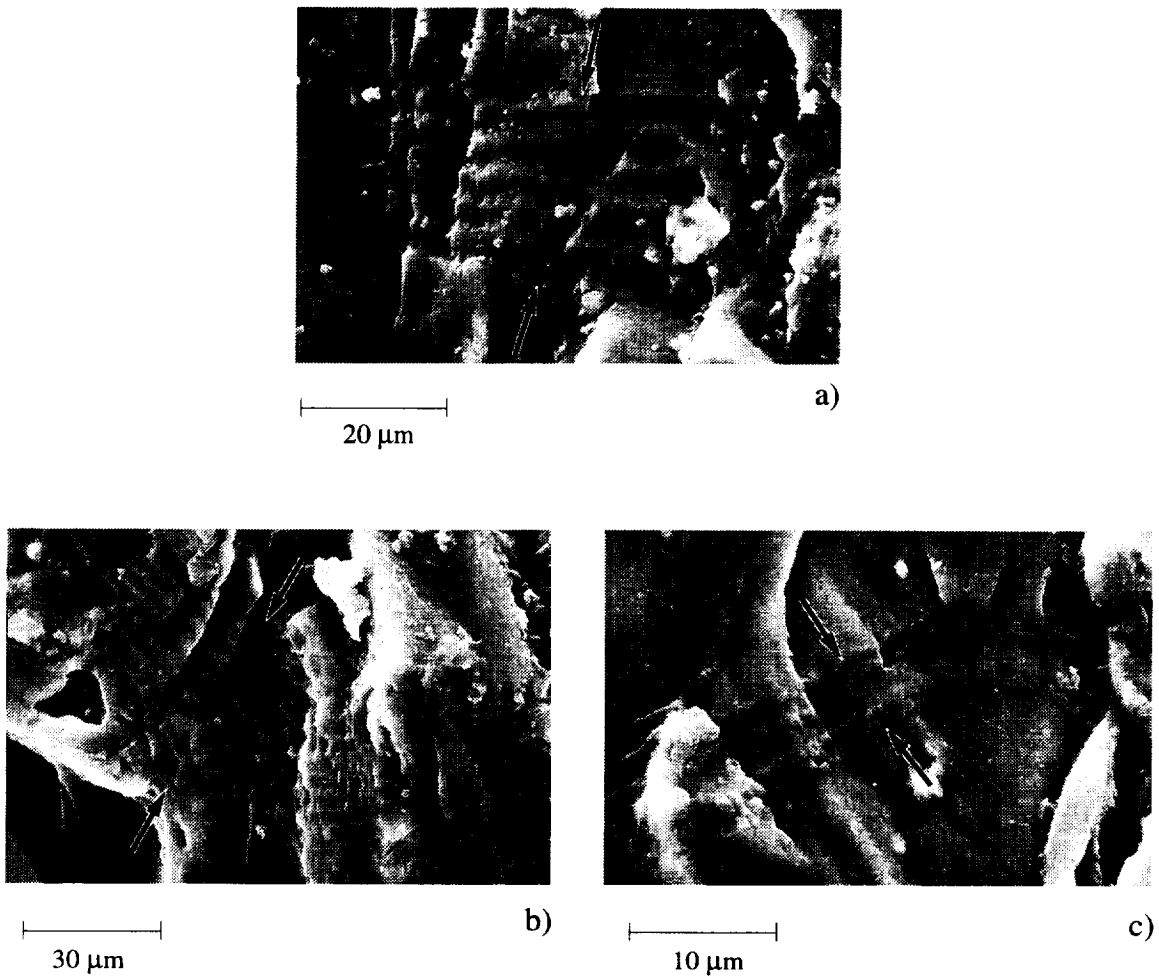
Figure. 14.1 SEM micrographs of: a) 6 marker bands between arrows comprising a 30 K set of marker bands. b) 10 marker bands between arrows comprising a 40 K set of marker bands. c) 4 marker bands between arrows comprising a 50 K set of marker bands.

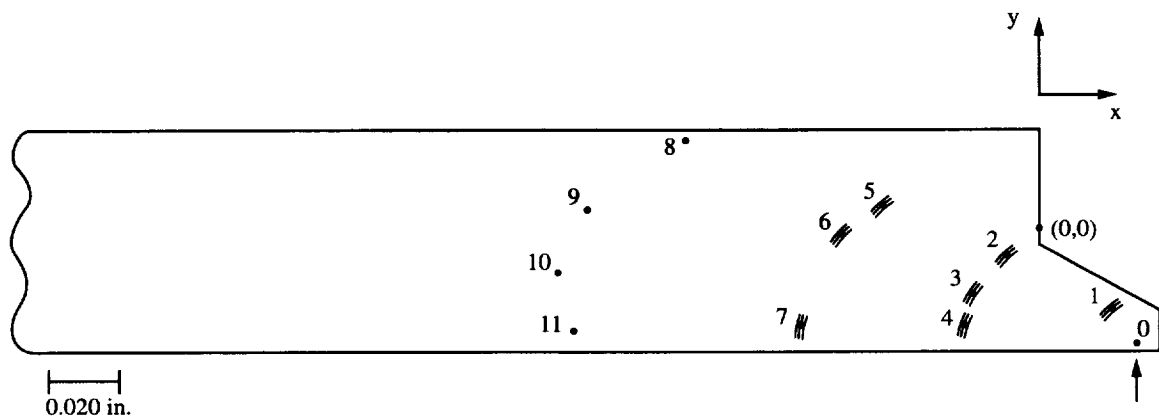
Figure 14.2 The schematic shows the initiation site, marker band and final crack front locations for the fatigue crack in rivet hole 3J1 that grew in the aft direction. Three sets of marker bands were found. The fatigue crack initiation region is marked with an arrow. The table summarizes the X-Y marker band coordinates relative to the origin (0,0), and the cycle count for each set of marker bands.

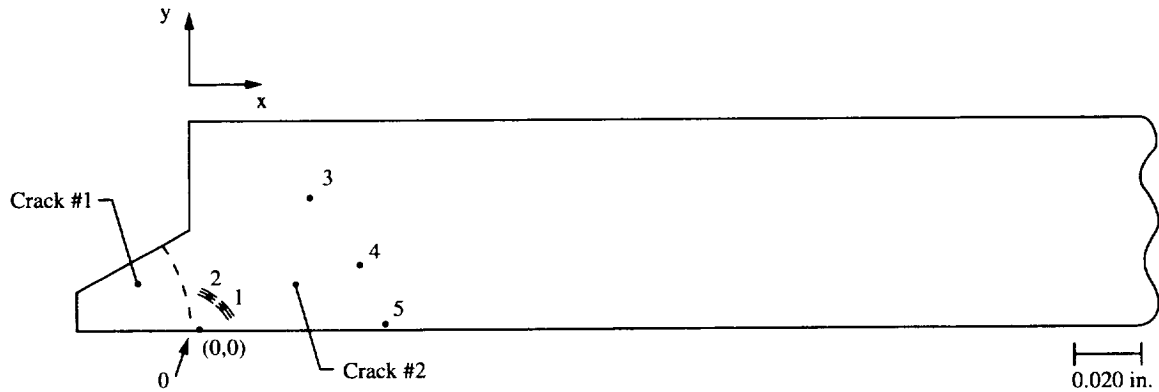
Figure 14.3 The schematic shows the initiation site, marker band and final crack front locations for the fatigue crack in rivet hole 3J1 that grew in the forward direction. This specimen contained two fatigue cracks. A set of marker bands was found radiating from the initiation region of crack #2. The fatigue crack initiation regions for cracks #1 and 2 are marked with a bracket and an arrow, respectively. The table summarizes the X-Y marker band coordinates relative to the origin (0,0), and the cycle count for each set of marker bands.

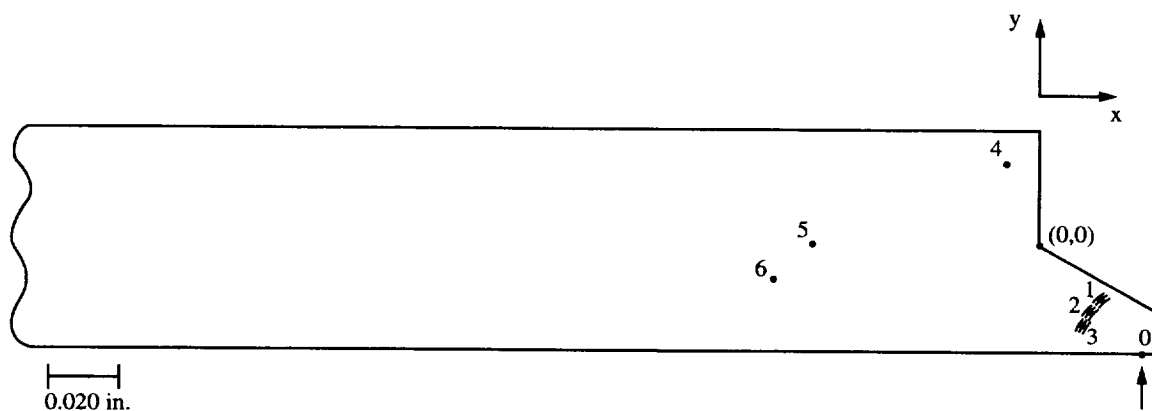
Figure 14.4 The schematic shows the initiation site, marker band and final crack front locations for the fatigue crack in rivet hole 3J2 that grew in the aft direction. One set of marker bands was found. The fatigue crack initiation region is marked with an arrow. The table summarizes the X-Y marker band coordinates relative to the origin (0,0), and the cycle count for each set of marker bands.

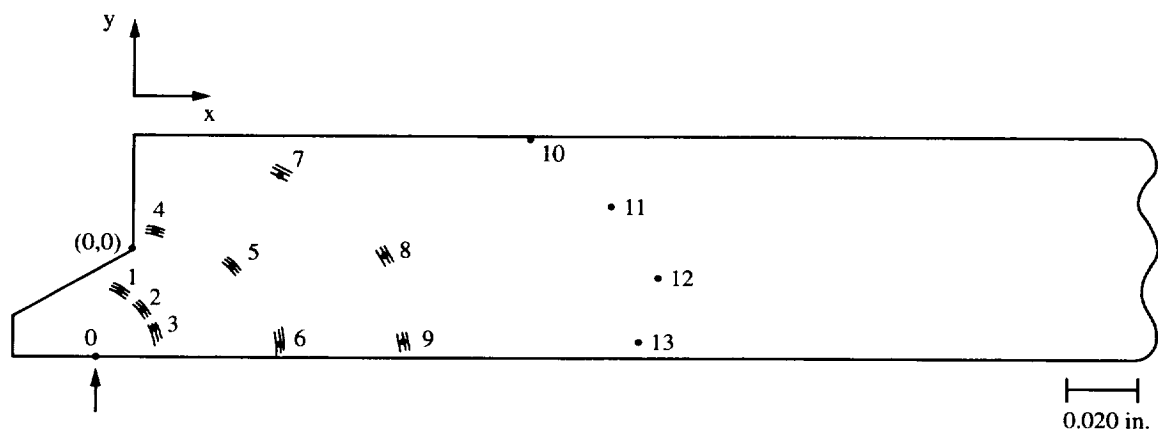
Figure 14.5 The schematic shows the initiation site, marker band and final crack front locations for the fatigue crack in rivet hole 3J2 that grew in the forward direction. Three sets of marker bands were found. The fatigue crack initiation region is marked with a bracket. The table summarizes the X-Y marker band coordinates relative to the origin(0,0), and the cycle count for each set of marker bands.

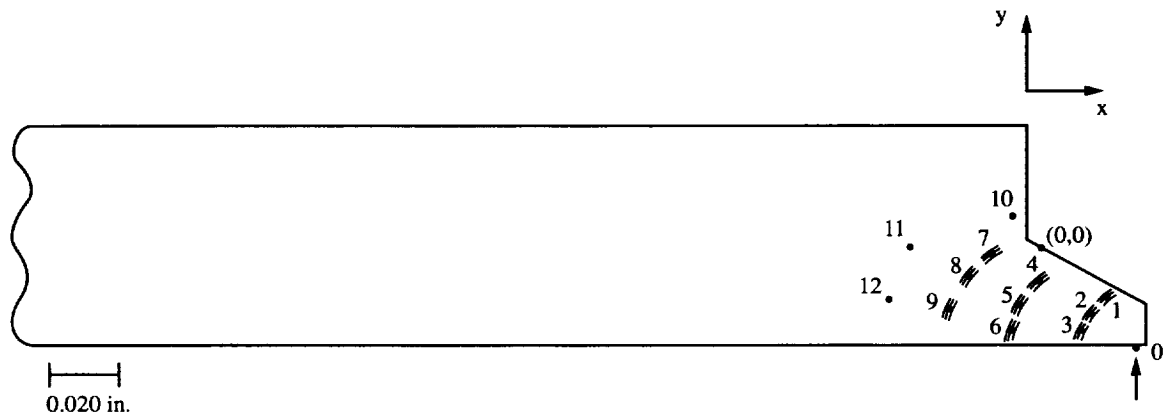
Figure 14.6 The schematic shows the initiation site, marker band and final crack front locations for the fatigue crack in rivet hole 3J4 that grew in the aft direction. Three sets of marker bands were found. The fatigue crack initiation region is marked with an arrow. The table summarizes the X-Y marker band coordinates relative to the origin (0,0), and the cycle count for each set of marker bands.

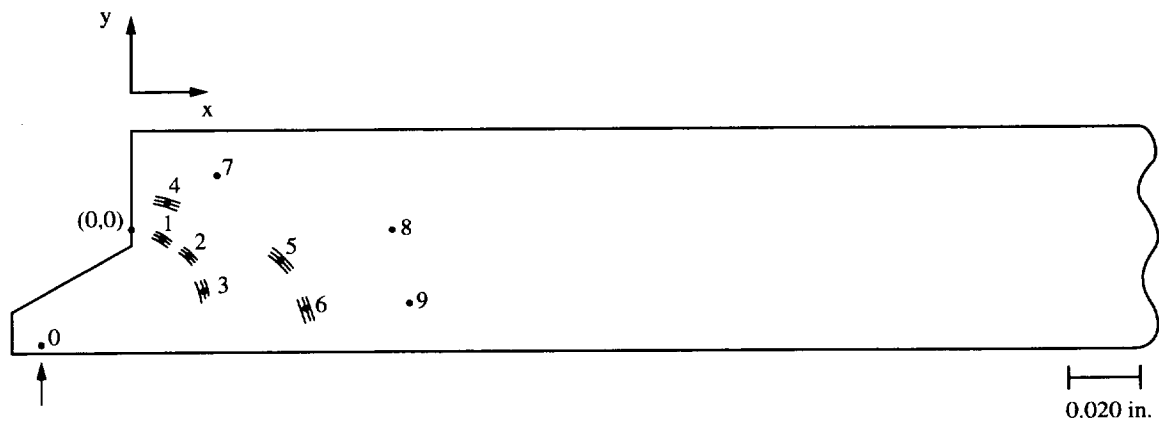
#	Coordinates (mm)	[in]	# of Bands (cycles)
0	(0.552-0.606,)	[0.027,-0.030]	Initiation
1	(0.2325,-0.025)	[0.009,-0.001]	9(40K)
2	(0.33,-0.17)	[0.013,-0.007]	9(40K)
3	(0.5125,-0.405)	[0.020,-0.016]	9(40K)
4	(0.2125,0.225)	[0.008,0.009]	4(50K)
5	(1.095,-0.175)	[0.043,-0.007]	4(50K)
6	(1.1625,-0.45)	[0.046,-0.018]	4(50K)
7	(0.4,0.595)	[0.016,0.024]	Crack Front
8	(1.95,0.0)	[0.077,0.000]	Crack Front
9	(2.005,-0.5)	[0.080,-0.020]	Crack Front

Figure 14.7 The schematic shows the initiation site, marker band and final crack front locations for the fatigue crack in rivet hole 3J4 that grew in the forward direction. Two sets of marker bands were found. The fatigue crack initiation region is marked with a bracket. The table summarizes the X-Y marker band coordinates relative to the origin (0,0), and the cycle count for each set of marker bands.

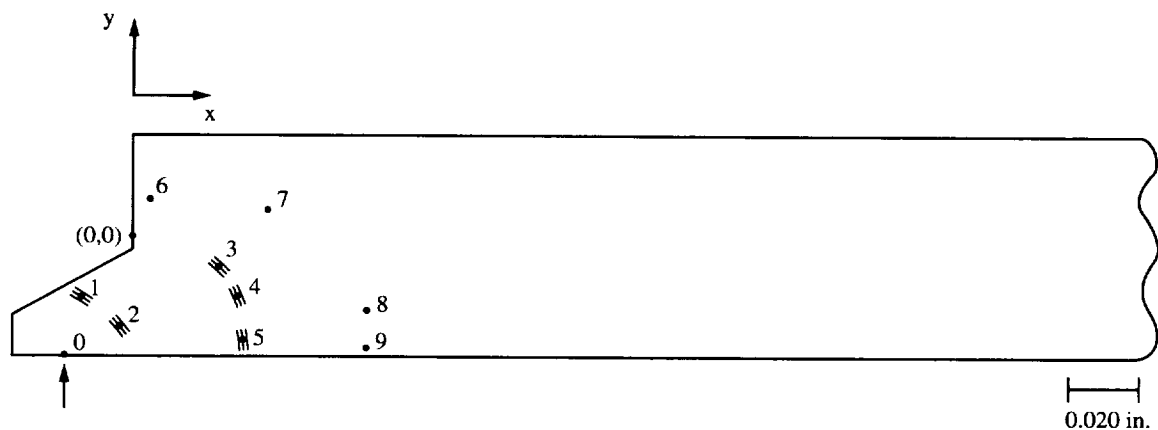
#	Coordinates (mm)	[in]	# of Bands (cycles)
0	(-0.390,-0.653)	[-0.019,-0.032]	Initiation
1	(-0.3125,-0.4125)	[-0.012,-0.016]	9(40K)
2	(-0.0625,-0.625)	[-0.002,-0.020]	9(40K)
3	(0.6175,-0.2125)	[0.024,-0.009]	4(50K)
4	(0.775,-0.4125)	[0.031,-0.016]	4(50K)
5	(0.825,-0.75)	[0.032,-0.030]	4(50K)
6	(0.12,0.29)	[0.005,0.011]	Crack Front
7	(1.0,0.24)	[0.039,0.009]	Crack Front
8	(1.75,-0.5)	[0.069,-0.020]	Crack Front
9	(1.71,-0.85)	[0.067,-0.033]	Crack Front

Figure 14.9 The schematic shows the initiation site, marker band and final crack front locations for the fatigue crack in rivet hole 3J7 that grew in the forward direction. Two sets of marker bands were found. The fatigue crack initiation region is marked with a bracket. The table summarizes the X-Y marker band coordinates relative to the origin (0,0), and the cycle count for each set of marker bands.

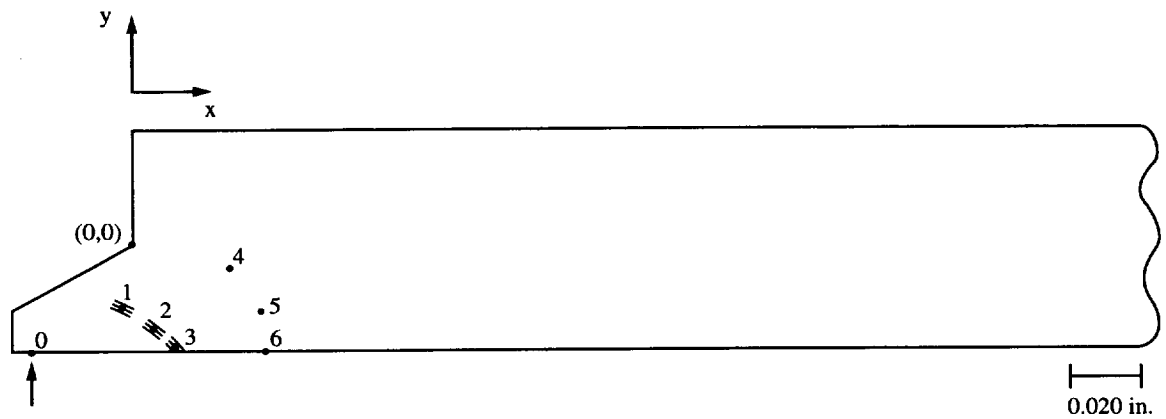
#	Coordinates (mm)	[in]	# of Bands (cycles)
0	(-0.513,-0.717)	[-0.025,-0.035]	Initiation
1	(-0.0875,-0.455)	[-0.003,-0.018]	4(50K)
2	(0.1625,-0.6025)	[0.006,-0.024]	4(50K)
3	(0.2725,-0.8125)	[0.011,-0.032]	4(50K)
4	(0.7,-0.2)	[0.028,-0.008]	Crack Front
5	(0.91,-0.5)	[0.036,-0.020]	Crack Front
6	(0.98,-0.91)	[0.039,-0.036]	Crack Front

Figure 14.10 The schematic shows the initiation site, marker band and final crack front locations for the fatigue crack in rivet hole 3J9 that grew in the aft direction. One set of marker bands was found. The fatigue crack initiation region is marked with a bracket. The table summarizes the X-Y marker band coordinates relative to the origin (0,0), and the cycle count for each set of marker bands.

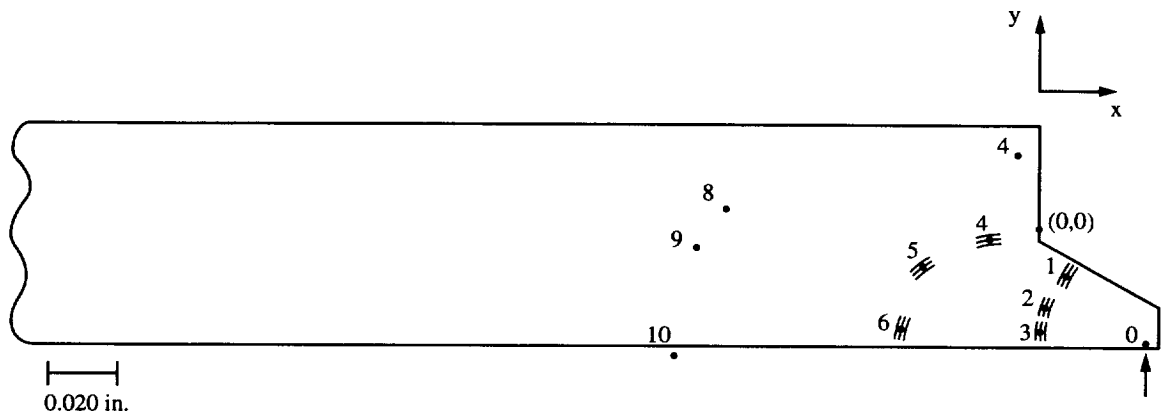
#	Coordinates (mm)	[in]	# of Bands (cycles)
0	(0.604,-0.588)	[0.030,-0.029]	Initiation
1	(0.0825,-0.1725)	[0.003,-0.007]	9(40K)
2	(-0.05,-0.3875)	[-0.002,-0.015]	9(40K)
3	(-0.05,-0.4875)	[-0.002,-0.019]	9(40K)
4	(-0.55,0.0375)	[-0.022,0.001]	4(50K)
5	(-1.0,-0.125)	[-0.039,-0.005]	4(50K)
6	(-1.1375,-0.6)	[-0.045,-0.024]	4(50K)
7	(-1.385,0.775)	[-0.055,0.031]	Crack Front
8	(-2.375,0.275)	[-0.094,0.011]	Crack Front
9	(-2.575,0.0)	[-0.101,0.000]	Crack Front
10	(-2.75,-0.775)	[-0.108,-0.031]	Crack Front

Figure 14.12 The schematic shows the initiation site, marker band and final crack front locations for the fatigue crack in rivet hole 3J12 that grew in the aft direction. Two sets of marker bands were found. The fatigue crack initiation region is marked with an arrow. The table summarizes the X-Y marker band coordinates relative to the origin (0,0), and the cycle count for each set of marker bands.

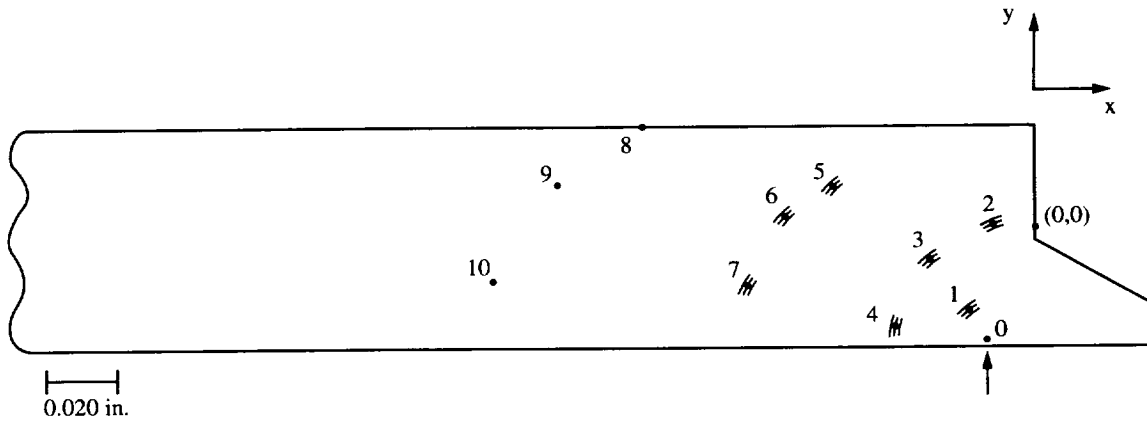
#	Coordinates (mm)	[in]	# of Bands (cycles)
0	(-0.339,-0.580)	[-0.017,-0.029]	Initiation
1	(-0.4325,-0.5675)	[-0.017,-0.022]	3(30K)
2	(-0.2625,0.0125)	[-0.010,0.0005]	9(40K)
3	(-0.75,-0.225)	[-0.030,-0.009]	9(40K)
4	(-0.995,-0.6625)	[-0.039,-0.026]	9(40K)
5	(-1.45,0.33)	[-0.057,0.013]	4(50K)
6	(-1.7875,0.125)	[-0.070,0.005]	4(50K)
7	(-2.1075,-0.4)	[-0.083,-0.016]	4(50K)
8	(-2.82,0.73)	[-0.111,0.029]	Crack Front
9	(-3.48,0.35)	[-0.137,0.014]	Crack Front
10	(-3.97,-0.38)	[-0.156,-0.015]	Crack Front

Figure 14.13 The schematic shows the initiation site, marker band and final crack front locations for the fatigue crack in rivet hole 3J12 that grew in the forward direction. Three sets of marker bands were found. The fatigue crack initiation region is marked with a bracket. The table summarizes the X-Y marker band coordinates relative to the origin(0,0), and the cycle count for each set of marker bands.

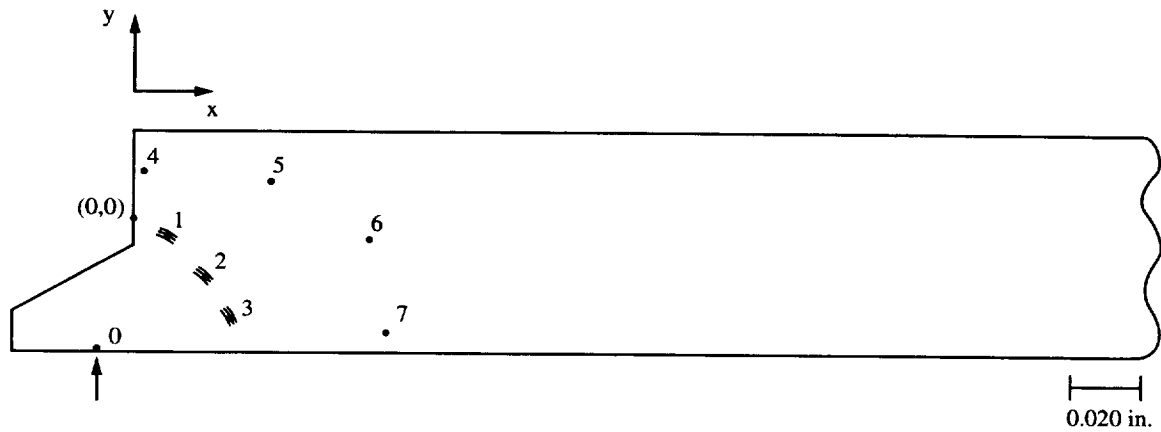
#	Coordinates (mm)	[in]	# of Bands (cycles)
0	(-0.274,-0.714)	[-0.013,-0.035]	Initiation
1	(0.25,-0.1175)	[0.01,-0.005]	9(40K)
2	(0.525,-0.3375)	[0.020,-0.013]	9(40K)
3	(0.7375,-0.675)	[0.029,-0.266]	9(40K)
4	(0.08,0.36)	[0.003,0.014]	Crack Front
5	(1.02,0.3)	[0.040,0.011]	Crack Front
6	(1.72,-0.2)	[0.068,-0.008]	Crack Front
7	(1.85,-0.78)	[0.073,-0.031]	Crack Front

Figure 14.14 The schematic shows the initiation site, marker band and final crack front locations for the fatigue crack in rivet hole 3J13 that grew in the forward direction. One set of marker bands was found. The fatigue crack initiation region is marked with a bracket. The table summarizes the X-Y marker band coordinates relative to the origin (0,0), and the cycle count for each set of marker bands.

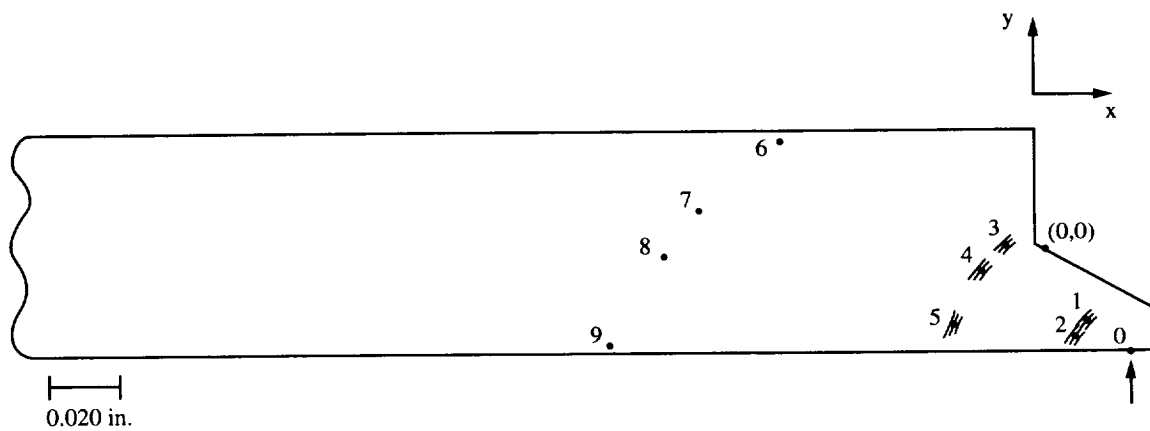
#	Coordinates (mm)	[in]	# of Bands (cycles)
0	(0.461,-0.589)	[0.023,-0.029]	Initiation
1	(0.2375,-0.5)	[0.009,-0.020]	3(30K)
2	(0.175,-0.64)	[0.007,-0.025]	3(30K)
3	(-0.325,0.0)	[-0.013,0.000]	9(40K)
4	(-0.525,-0.1625)	[-0.021,-0.006]	9(40K)
5	(-0.7125,-0.55)	[-0.028,-0.022]	9(40K)
6	(-1.95,0.79)	[-0.077,0.031]	Crack Front
7	(-2.55,0.28)	[-0.100,0.011]	Crack Front
8	(-2.84,-0.05)	[-0.112,-0.002]	Crack Front
9	(-3.2,-0.7)	[-0.126,-0.028]	Crack Front

Figure 14.15 The schematic shows the initiation site, marker band and final crack front locations for the fatigue crack in rivet hole 3J15 that grew in the aft direction. Two sets of marker bands were found. The fatigue crack initiation region is marked with a bracket. The table summarizes the X-Y marker band coordinates relative to the origin (0,0), and the cycle count for each set of marker bands.

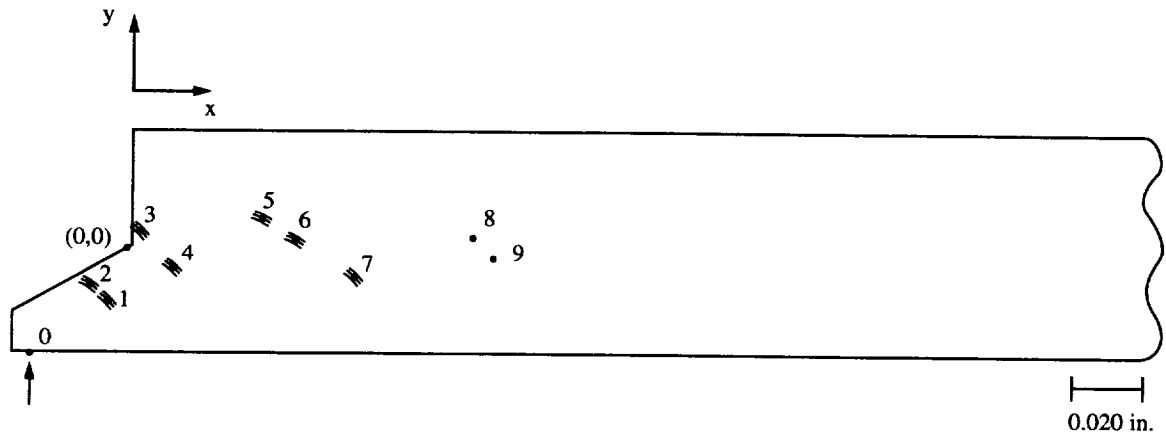
#	Coordinates (mm)	[in]	# of Bands (cycles)
0	(-0.542,-0.590)	[-0.027,-0.029]	Initiation
1	(-0.15,-0.37)	[-0.006,-0.015]	3(30K)
2	(-0.29,-0.2625)	[-0.011,-0.010]	3(30K)
3	(0.135,-0.0375)	[0.005,-0.001]	9(40K)
4	(0.3,-0.175)	[0.012,-0.007]	9(40K)
5	(0.9825,0.225)	[0.039,0.009]	4(50K)
6	(1.1875,0.095)	[0.047,0.004]	4(50K)
7	(1.625,-0.2325)	[0.064,-0.009]	4(50K)
8	(1.67,0.8)	[0.066,0.031]	Crack Front
9	(2.5,0.25)	[0.098,0.010]	Crack Front

Figure 14.16 The schematic shows the initiation site, marker band and final crack front locations for the fatigue crack in rivet hole 3J15 that grew in the forward direction. Three sets of marker bands were found. The fatigue crack initiation region is marked with a bracket. The table summarizes the X-Y marker band coordinates relative to the origin (0,0), and the cycle count for each set of marker bands.

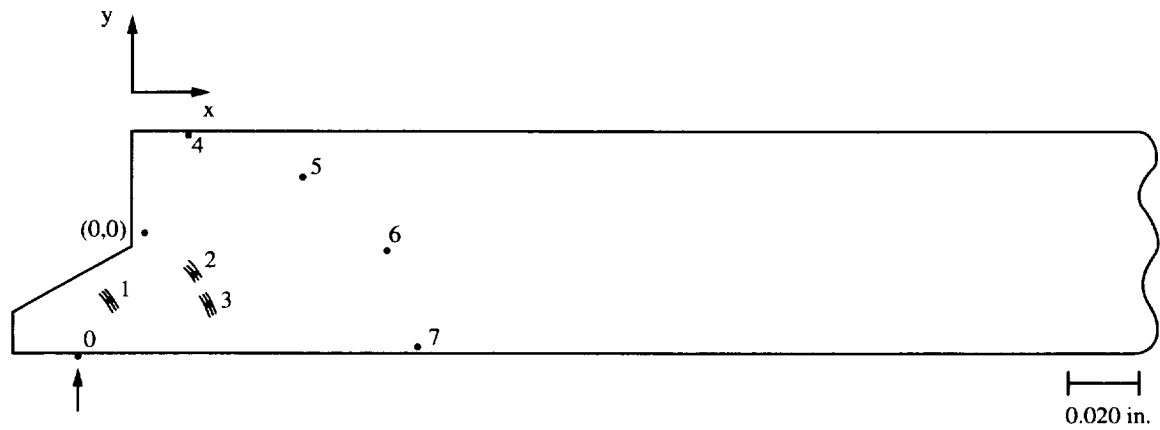
#	Coordinates (mm)	[in]	# of Bands (cycles)
0	(-0.432,-0.710)	[-0.021,-0.035]	Initiation
1	(-0.27,-0.463)	[-0.011,-0.018]	6(30K)
2	(0.35,-0.275)	[0.014,-0.011]	9(40K)
3	(0.45,-0.525)	[0.018,-0.021]	9(40K)
4	(0.3,0.65)	[0.012,0.026]	Crack Front
5	(1.13,0.39)	[0.044,0.015]	Crack Front
6	(1.8,-0.11)	[0.071,-0.004]	Crack Front
7	(1.97,-0.85)	[0.078,-0.033]	Crack Front

Figure 14.17 The schematic shows the initiation site, marker band and final crack front locations for the fatigue crack in rivet hole 4J1 that grew in the aft direction. Two sets of marker bands were found. The fatigue crack initiation region is marked with an arrow. The table summarizes the X-Y marker band coordinates relative to the origin (0,0), and the cycle count for each set of marker bands.

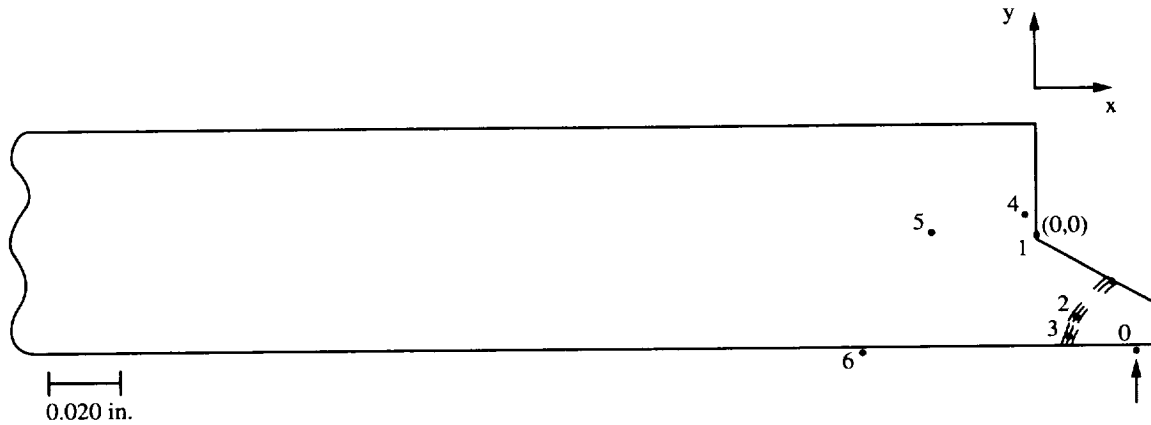
#	Coordinates (mm)	[in]	# of Bands (cycles)
0	(0.534,-0.650)	[0.026,-0.032]	Initiation
1	(0.5625,-0.3125)	[0.022,-0.012]	10(40K)
2	(0.300,-0.575)	[0.012,-0.023]	10(40K)
3	(0.255,-0.775)	[0.010,-0.031]	10(40K)
4	(-0.07,0.18)	[-0.003,0.007]	Crack Front
5	(-0.75,0.0)	[-0.029,0.000]	Crack Front
6	(-1.29,-0.85)	[-0.041,-0.033]	Crack Front

Figure 14.19 The schematic shows the initiation site, marker band and final crack front locations for the fatigue crack in rivet hole 4J2 that grew in the aft direction. One set of marker bands was found. The fatigue crack initiation region is marked with an arrow. The table summarizes the X-Y marker band coordinates relative to the origin (0,0), and the cycle count for each set of marker bands.

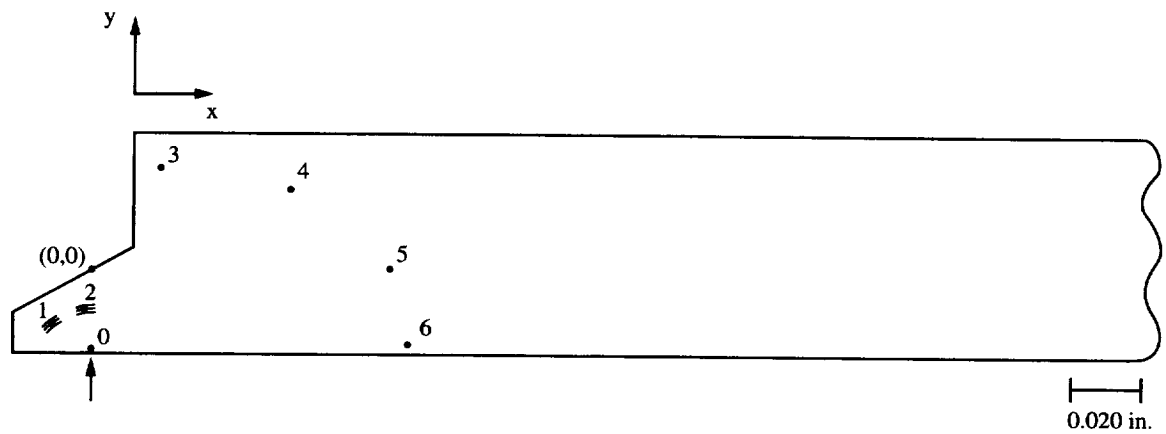
#	Coordinates (mm)	[in]	# of Bands (cycles)
0	(-0.016,-0.454)	[-0.001,-0.022]	Initiation
1	(-0.068,-0.275)	[-0.003,-0.011]	6(30K)
2	(-0.288,-0.323)	[-0.011,-0.013]	6(30K)
3	(0.47,0.72)	[0.019,0.028]	Crack Front
4	(1.43,0.6)	[0.056,0.024]	Crack Front
5	(1.95,0.0)	[0.077,0.000]	Crack Front
6	(2.08,-0.5)	[0.082,-0.020]	Crack Front

Figure 14.20 The schematic shows the initiation site, marker band and final crack front locations for the fatigue crack in rivet hole 4J3 that grew in the forward direction. One set of marker bands was found. The fatigue crack initiation region is marked with an arrow. The table summarizes the X-Y marker band coordinates relative to the origin (0,0), and the cycle count for each set of marker bands.

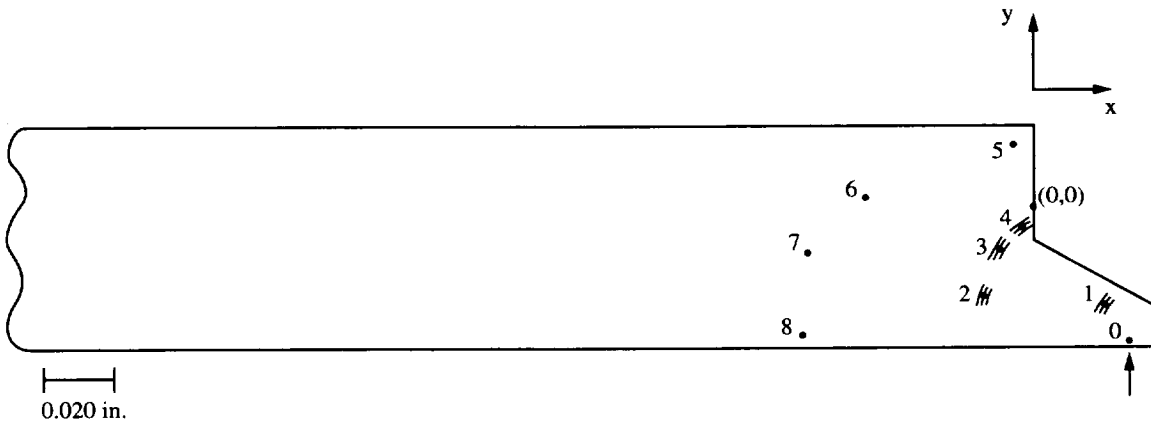
#	Coordinates (mm)	[in]	# of Bands (cycles)
0	(0.522,-0.658)	[0.026,-0.032]	Initiation
1	(0.525,-0.5675)	[0.021,-0.022]	10(40K)
2	(-0.3625,-0.500)	[-0.014,-0.020]	4(50K)
3	(-0.250,-0.1875)	[-0.010,-0.007]	4(50k)
4	(-0.0125,0.0125)	[-0.0004,0.0004]	4(50K)
5	(-0.15,0.58)	[-0.006,0.023]	Crack Front
6	(-1.21,0.2)	[-0.048,0.008]	Crack Front
7	(-1.65,-0.2)	[-0.065,-0.008]	Crack Front
8	(-1.72,-0.9)	[-0.068,-0.035]	Crack Front

Figure 14.21 The schematic shows the initiation site, marker band and final crack front locations for the fatigue crack in rivet hole 4J4 that grew in the forward direction. Two sets of marker bands were found. The fatigue crack initiation region is marked with a bracket. The table summarizes the X-Y marker band coordinates relative to the origin (0,0), and the cycle count for each set of marker bands.

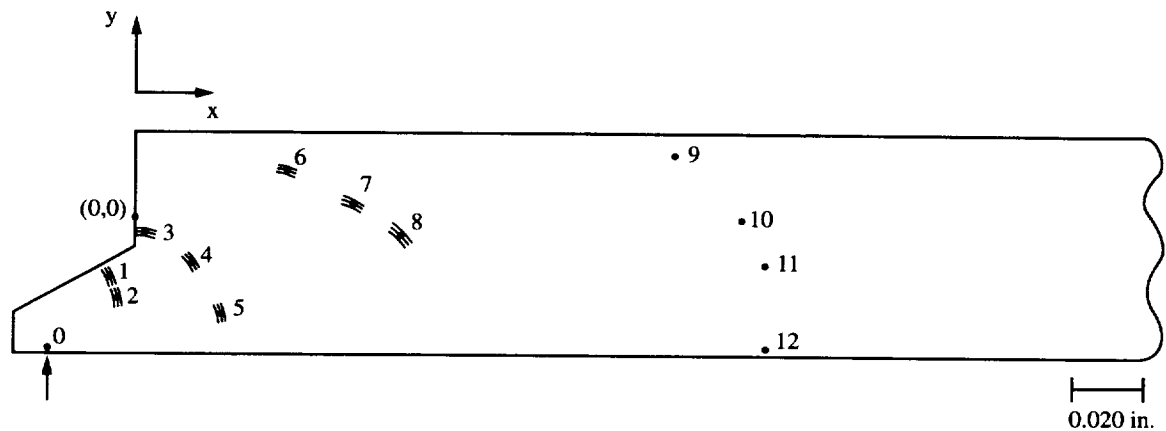
#	Coordinates (mm)	[in]	# of Bands (cycles)
0	(-0.468,-0.712)	[-0.023,-0.035]	Initiation
1	(-0.238,-0.413)	[-0.009,-0.016]	6(30K)
2	(-0.163,-0.5375)	[-0.006,-0.021]	6(30k)
3	(0.050,-0.075)	[0.002,-0.003]	9(40K)
4	(0.483,-0.260)	[0.019,-0.010]	9(40K)
5	(0.563,-0.663)	[0.022,-0.026]	9(40K)
6	(1.100,0.35)	[0.043,0.013]	4(50K)
7	(1.600,0.1375)	[0.063,0.005]	4(50K)
8	(1.950,-0.0875)	[0.077,-0.003]	4(50K)
9	(3.93,0.53)	[0.155,0.021]	Crack Front
10	(4.45,0.0)	[0.175,0.0]	Crack Front
11	(4.6,-0.3)	[0.181,-0.012]	Crack Front
12	(4.65,-0.9)	[0.183,-0.035]	Crack Front

Figure 14.22 The schematic shows the initiation site, marker band and final crack front locations for the fatigue crack in rivet hole 4J5 that grew in the aft direction. There were 3 sets of marker bands found. The fatigue crack initiation region is marked with a bracket. The table summarizes the X-Y marker band coordinates relative to the origin (0,0), and the cycle count for each set of marker bands.

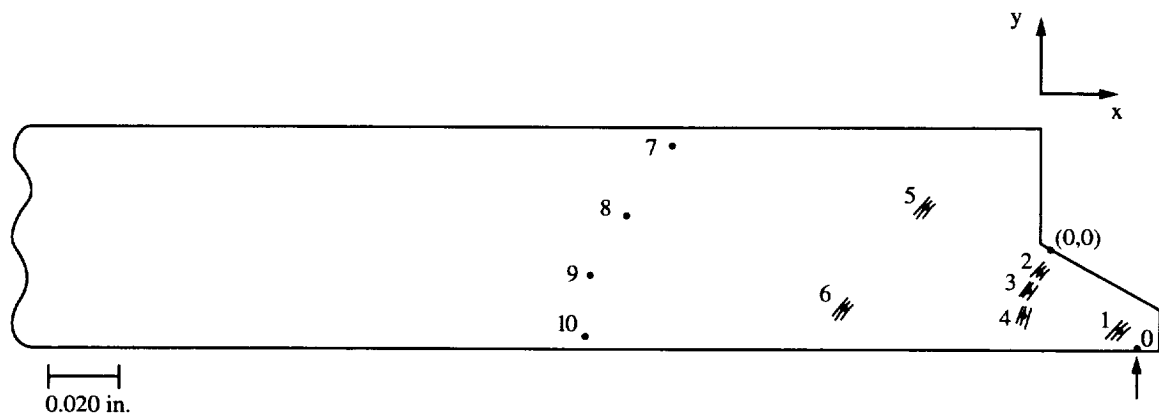
Figure 14.23 The schematic shows the initiation site, marker band and final crack front locations for the fatigue crack in rivet hole 4J5 that grew in the forward direction. There were 2 sets of marker bands found. The fatigue crack initiation region is marked with an arrow. The table summarizes the X-Y marker band coordinates relative to the origin (0,0), and the cycle count for each set of marker bands.

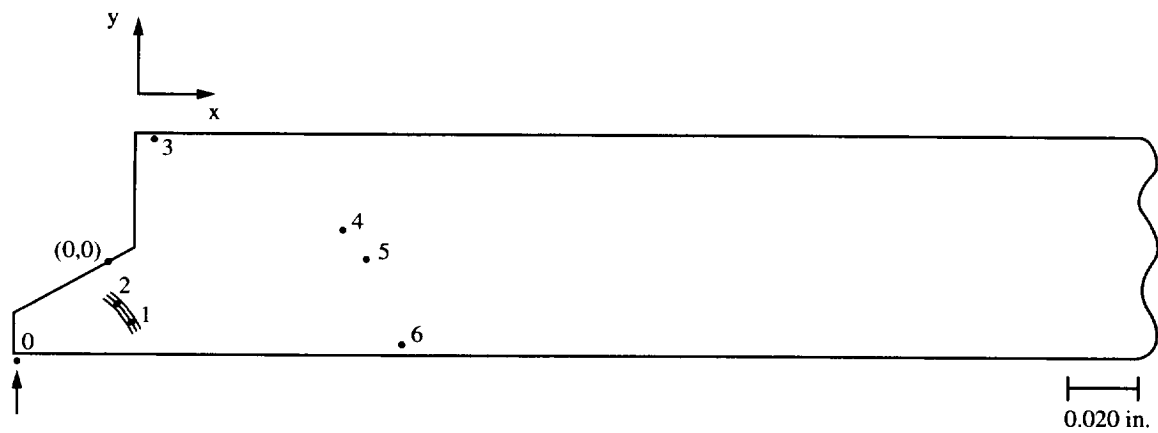
Figure 14.24 The schematic shows the initiation site, marker band and final crack front locations for the fatigue crack in rivet hole 4J6 that grew in the forward direction. There were 3 sets of marker bands found. The fatigue crack initiation region is marked with an arrow. The table summarizes the X-Y marker band coordinates relative to the origin (0,0), and the cycle count for each set of marker bands.

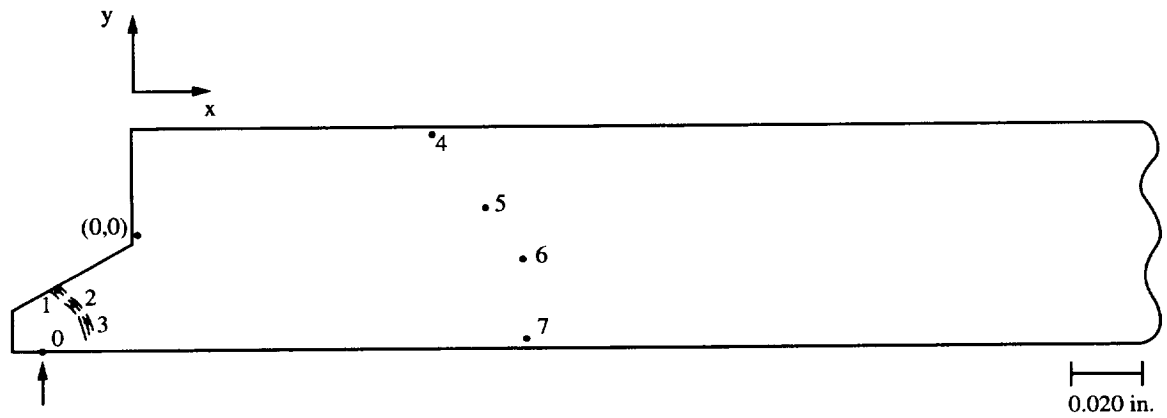
Figure 14.25 The schematic shows the initiation site, marker band and final crack front locations for the fatigue crack in rivet hole 4J6 that grew in the aft direction. Only one set of marker bands was found. The fatigue crack initiation region is marked with an arrow. The table summarizes the X-Y marker band coordinates relative to the origin (0,0), and the cycle count for each set of marker bands.

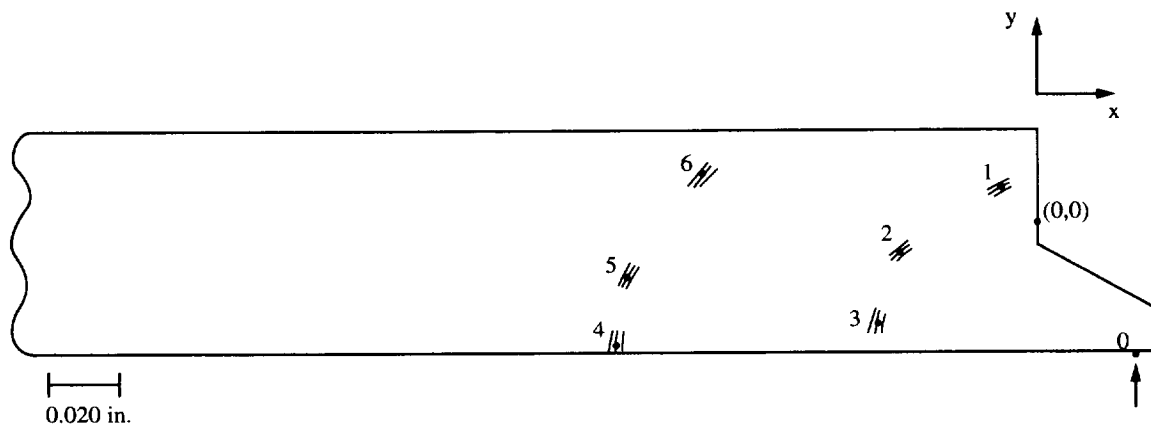
Figure 14.26 The schematic shows the initiation site, marker band and final crack front locations for the fatigue crack in rivet hole 4J7 that grew in the forward direction. Two sets of marker bands were found. The fatigue crack initiation region is marked with an arrow. The table summarizes the X-Y marker band coordinates relative to the origin (0,0), and the cycle count for each set of marker bands.

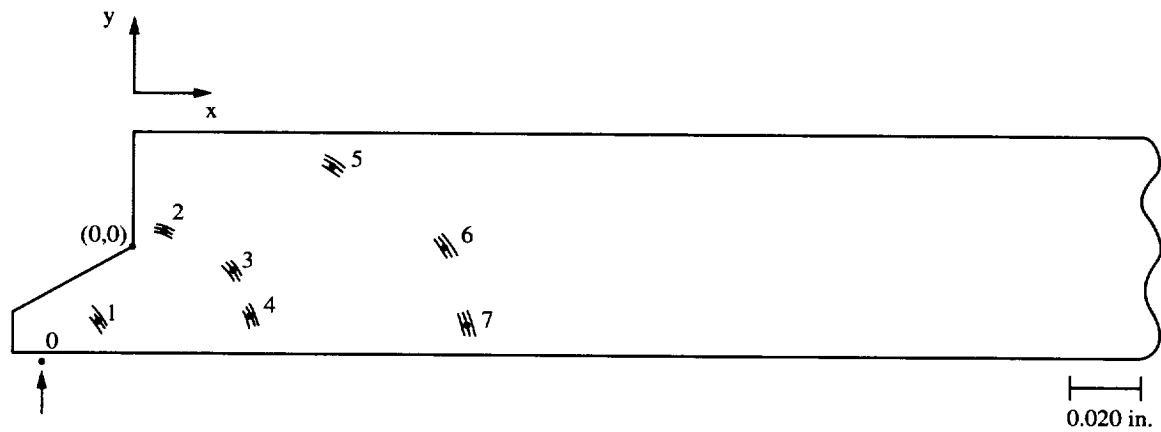
Figure 14.27 The schematic shows the marker band locations for the fatigue crack in rivet hole 4J8 that grew in the forward direction. Two sets of marker bands were found. The fatigue crack initiation region is marked with an arrow. The table summarizes the X-Y marker band coordinates relative to the origin (0,0), and the cycle count for each set of marker bands.

- No crack front. Crack linked up with 4J9B.
